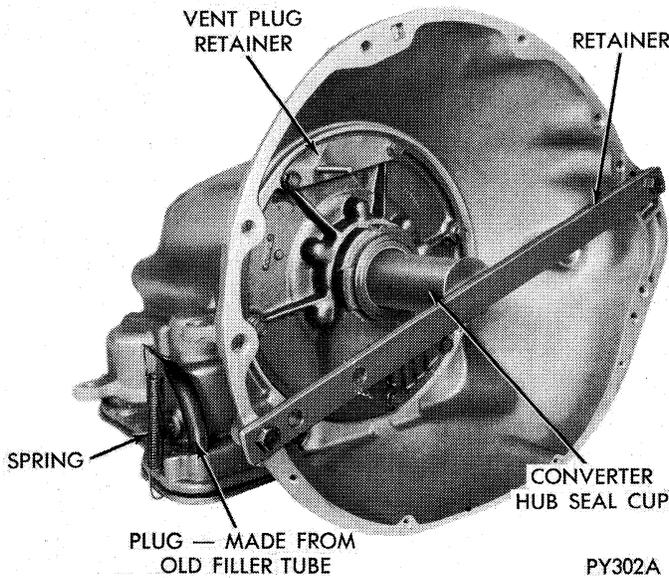
**Fig. 12—Transmission Prepared for Test**

If a leak source is located, that part and all associated seals and gaskets should be replaced with new parts.

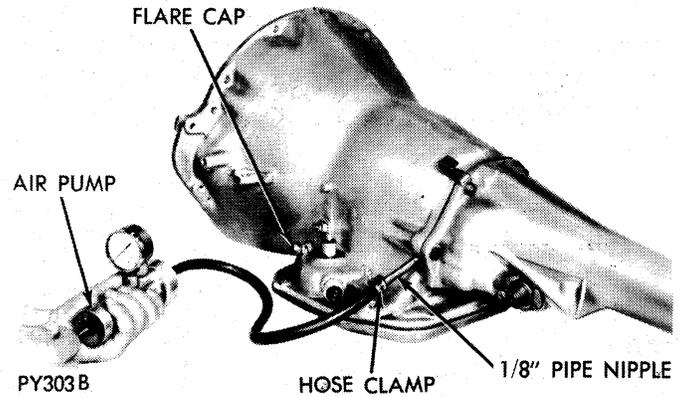
**Fig. 13—Pressurizing Transmission**
